**PRELIMINARY ASSESSMENT/  
VISUAL SITE INSPECTION**

**HASCO SPRING INDUSTRIES, INC.  
(FORMERLY PARMCO-OHIO)  
JEFFERSON, OHIO  
OHD 004 172 276**

**FINAL REPORT**

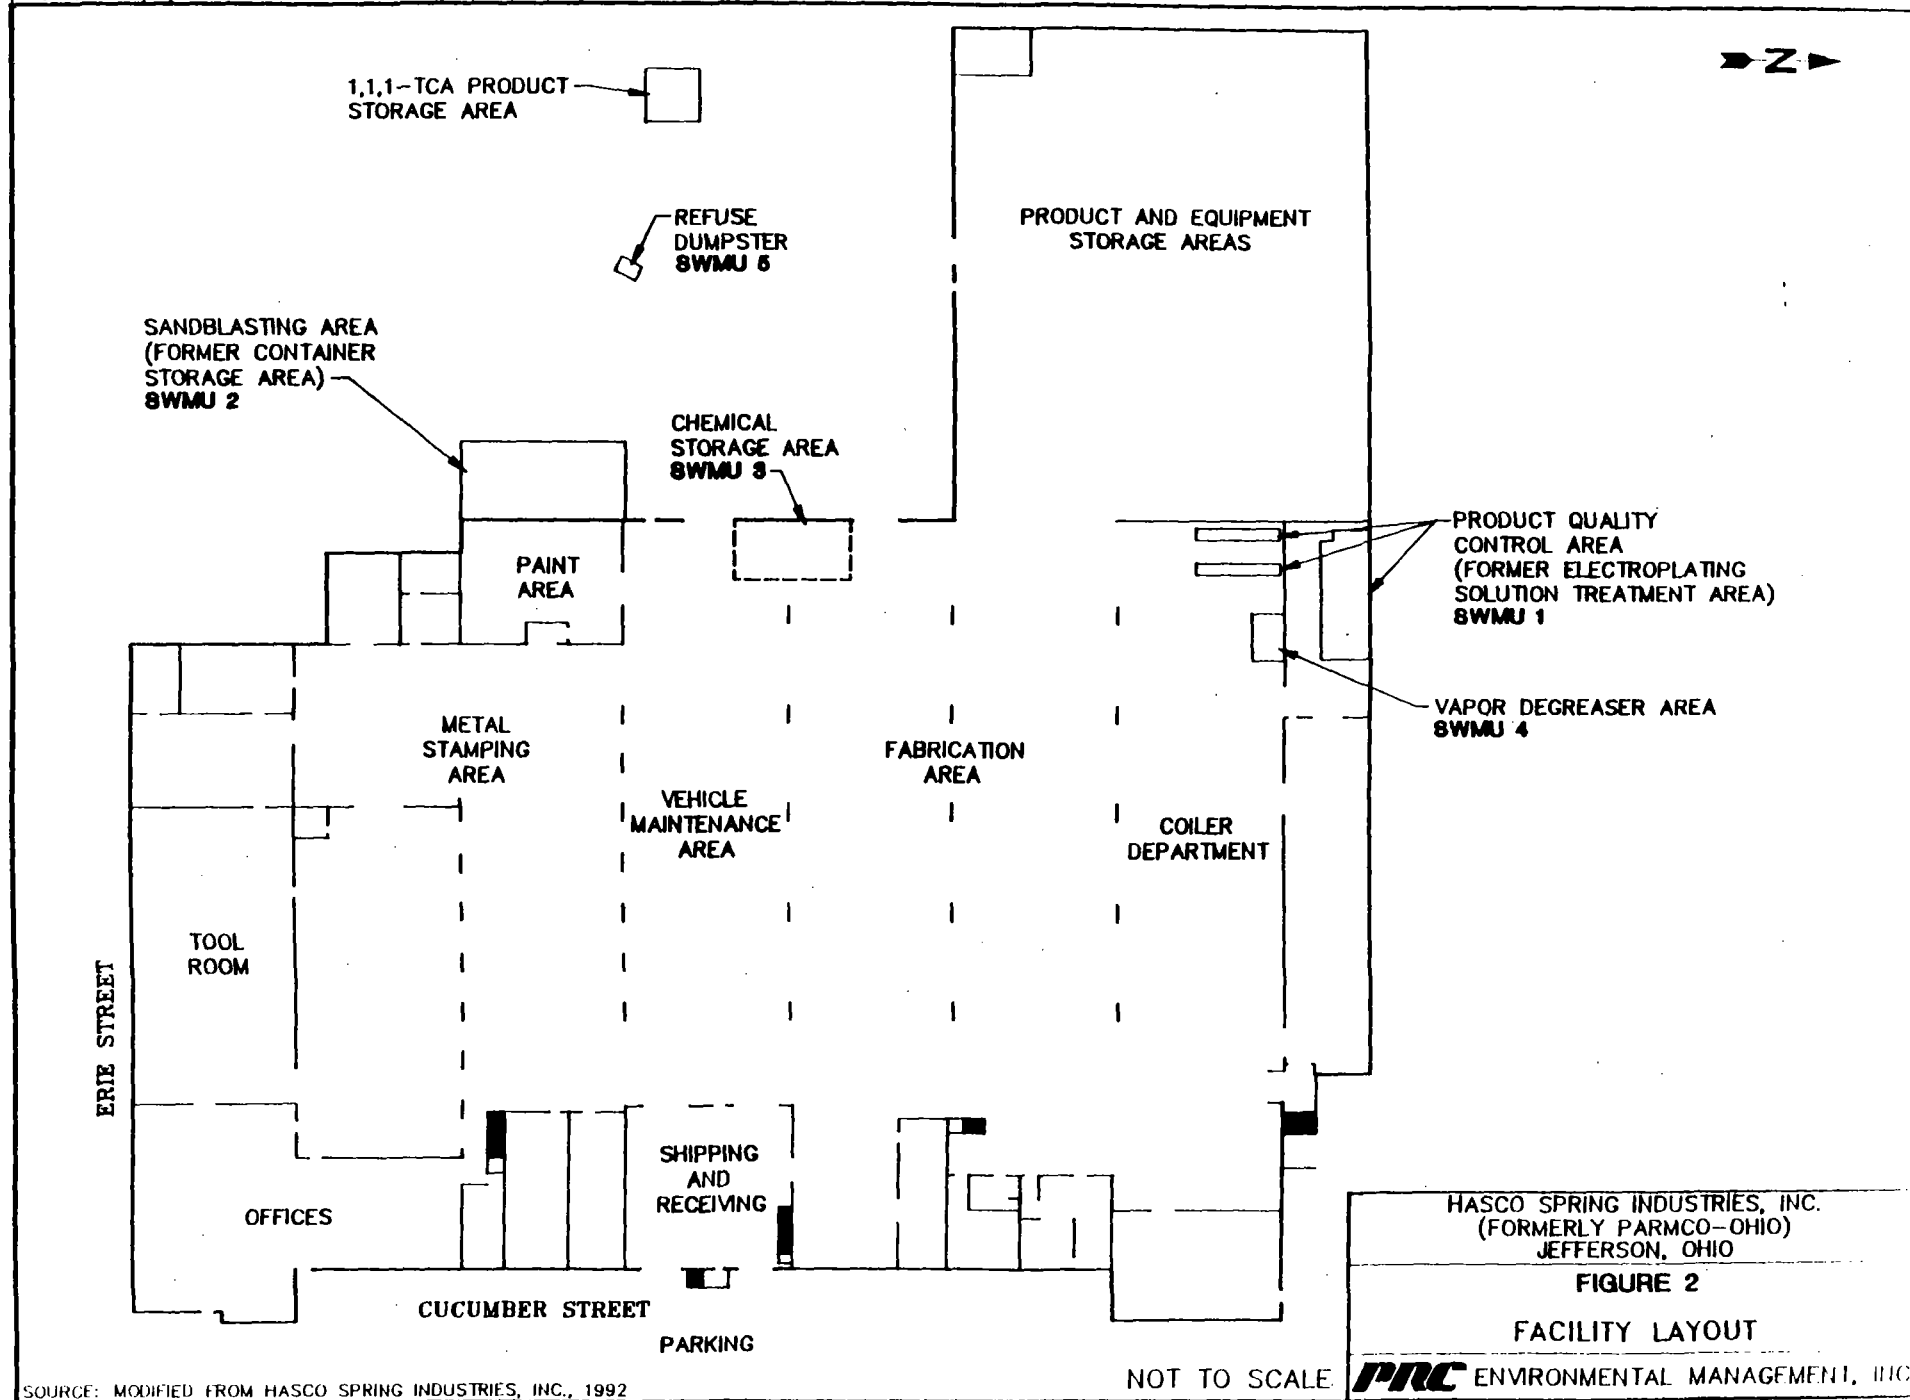
**FIGURE 2**

This section describes waste generation and management at the Hasco facility. Facility SWMUs are identified in Table 1. The facility layout, including SWMUs and AOCs, is shown in Figure 2. Facility waste streams are summarized in Table 2.

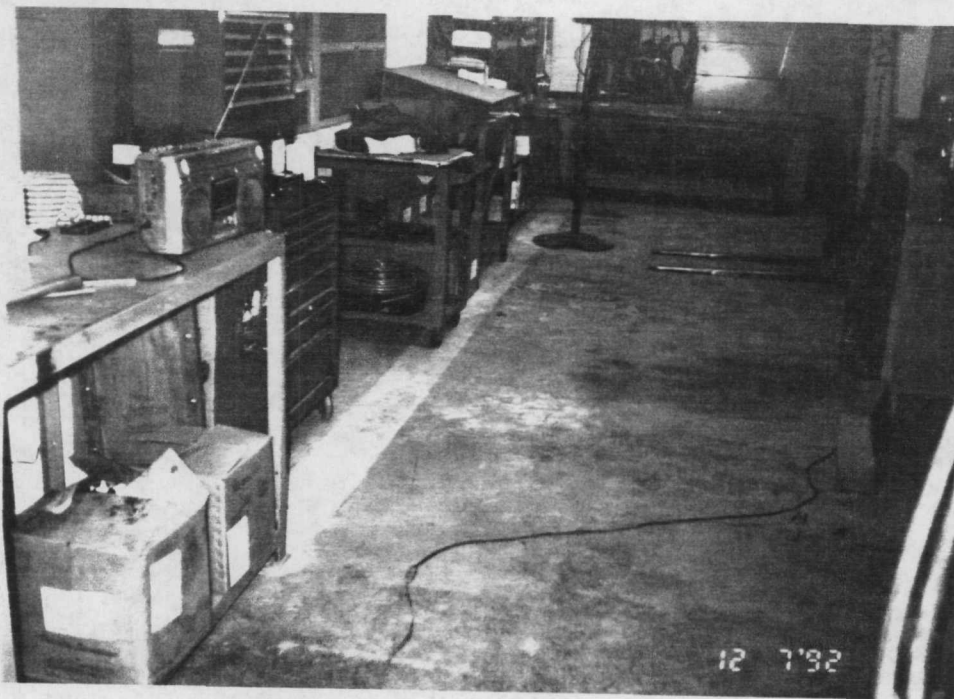
Photograph No. 1

During the VSI, PRC observed that the two trenches and two concrete tanks had been filled with concrete. The location of this unit is currently used for quality control testing of counterbalance springs. PRC noted no evidence of release (see Photographs No. 1 and 2).

Description: The white concrete strip on the left side of the floor is one of two concrete-filled trenches in the Former Electroplating Solution Treatment Area (SWMU 1). The second concrete trench is located about 15 feet east of this trench, to the right, and is not visible in this photograph.

**Recommendations:**              PRC recommends no further action for this unit at this time.

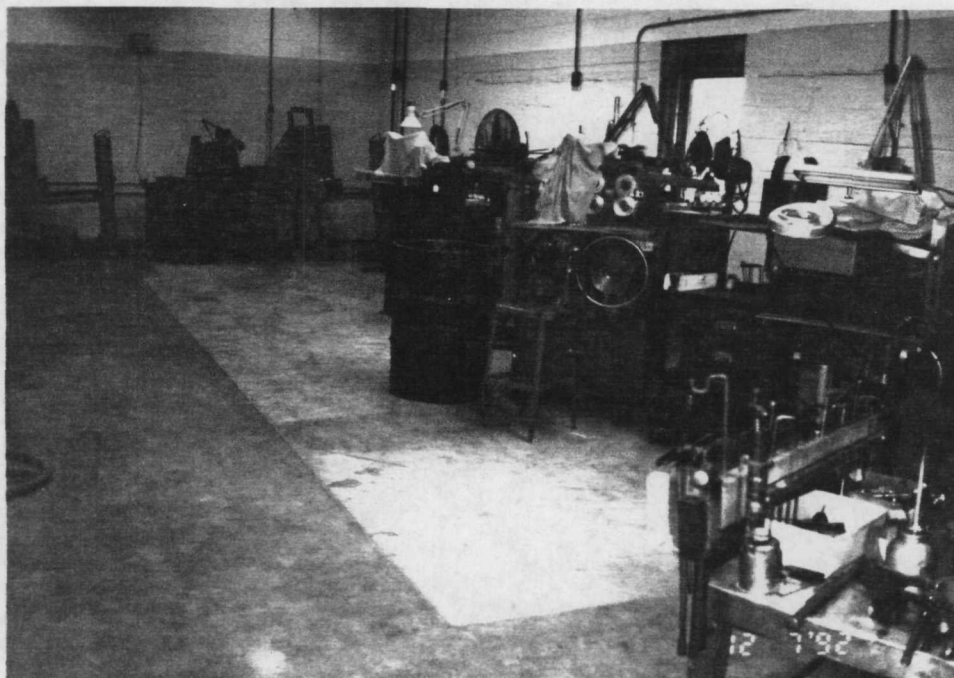
Photograph No. 2

Description: White concrete areas in the center of the photograph mark the location of the two concrete-filled below-grade concrete tanks in the Former Electroplating Solution Treatment Area (SWMU 1). The two 55-gallon drums in the center and to the left of the photograph accumulate nonhazardous general refuse.

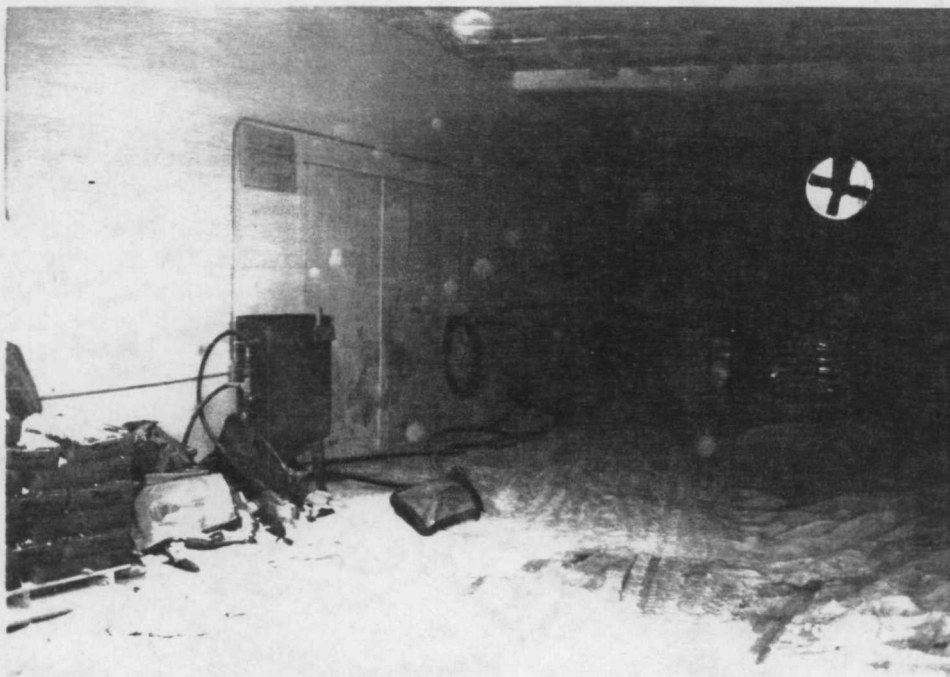
Photograph No. 3

**Observations:** During the VSI, the unit contained sandblasting equipment and packaged sandblasting grit. This unit also contained loose sandblasting grit on the concrete pad. Due to large amounts of sandblasting grit on the pad, PRC was unable to note any evidence of release (see Photographs No. 3 and 4).

Description: This photograph shows the location of the Former Container Storage Area (SWMU 2). This unit is currently used for sandblasting operations. Fine-grained material on the unit's floor is sandblasting grit.

Recommendations: PRC recommends no further action for this unit at this time.

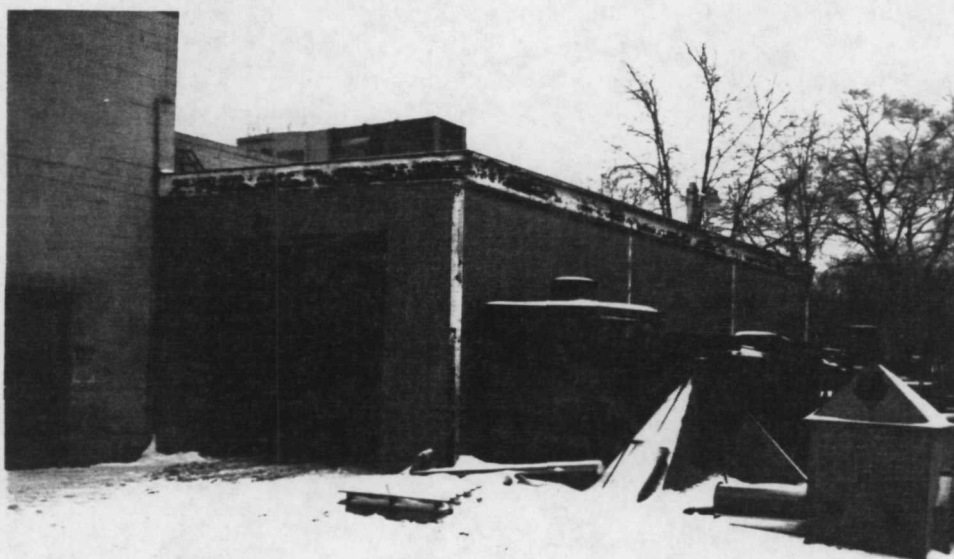
Photograph No. 4

Description: The enclosed area is the Former Container Storage Area (SWMU 2). Material on the right side of photograph is miscellaneous unused equipment.

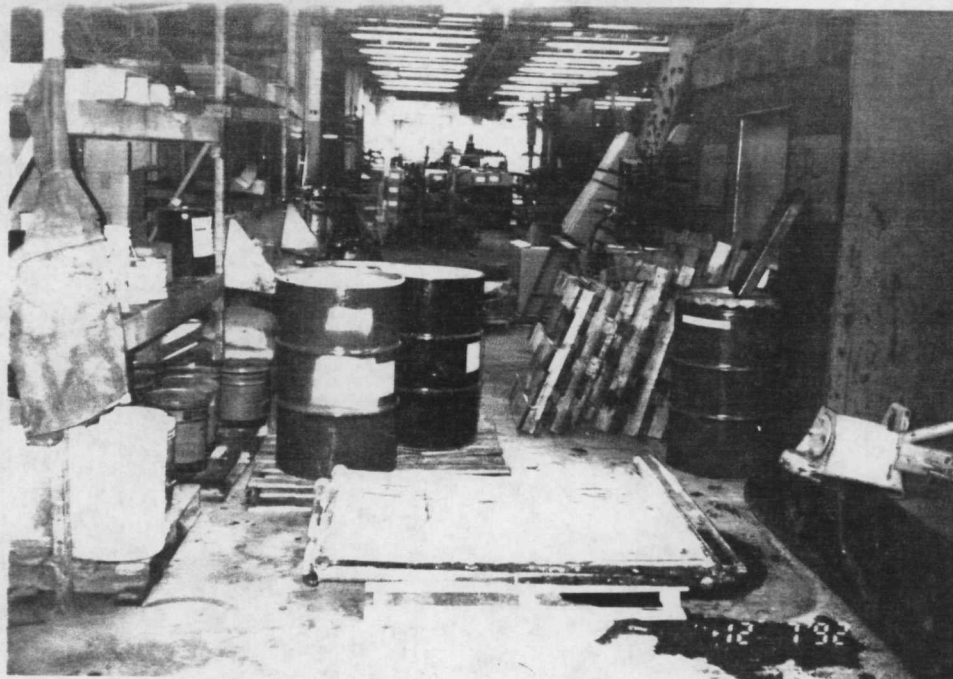
Photograph No. 5

**Observations:** During the VSI, the unit contained two full 55-gallon drums of hazardous waste 1,1,1-TCA still bottoms; one full drum of nonhazardous waste oil; and one full drum of nonhazardous waste antifreeze. PRC noted oil staining and absorbent spill cleanup material in the south end of this unit (see Photograph No. 5).

Hazardous waste is managed in covered 55-gallon drums on a concrete surface at the Chemical Storage Area. No releases from this unit have been documented. During the VSI, PRC observed an oil-stained area covered with absorbent material at the south end of this unit. It is unlikely that a release would leave the enclosed area. Therefore, there is a low potential for release to all environmental media.

Description: This photograph shows the Chemical Storage Area (SWMU 3). Two 55-gallon drums in center of photograph contain waste 1,1,1-TCA still bottoms; the 55-gallon drum in right foreground contains nonhazardous waste oil; the 55-gallon drum in right background contains nonhazardous waste antifreeze. Note the oil stains and absorbent material in the lower right of the photograph.

Recommendations: PRC recommends no further action for this unit at this time.

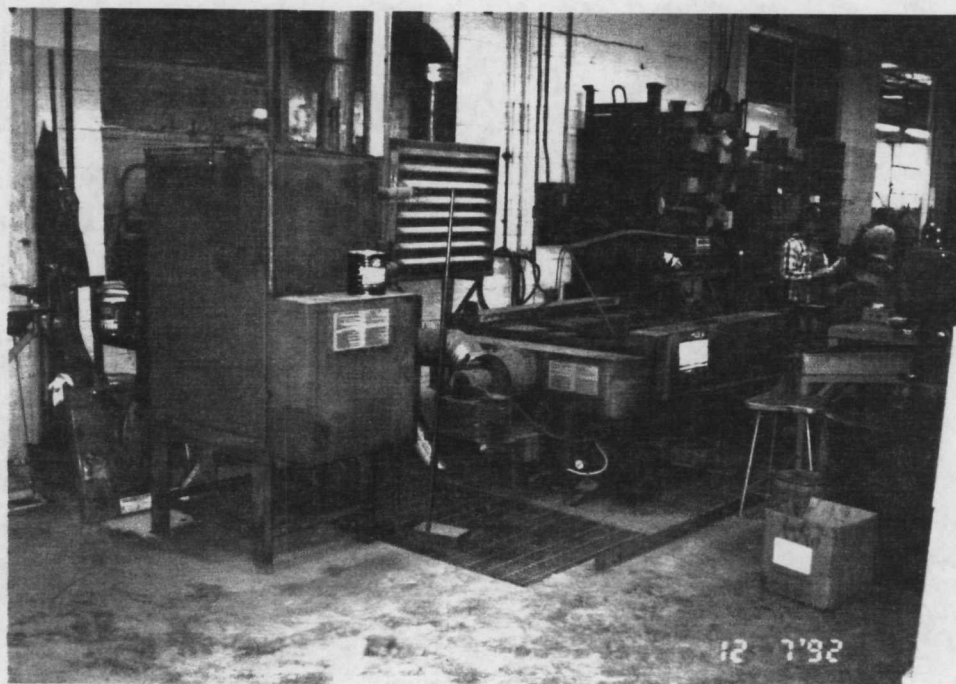
Photograph No. 6

The unit was not in operation during the VSI. PRC noted no evidence of release (see Photograph No. 6).

Description: This photograph shows the Vapor Degreaser Area (SWMU 4). A vapor degreasing unit is located on top of the metal grating. A 15-foot by 8-foot by 3-foot concrete pit lies underneath. A distillation unit is located to the left on a concrete floor.

Recommendations: PRC recommends no further action for this unit at this time.

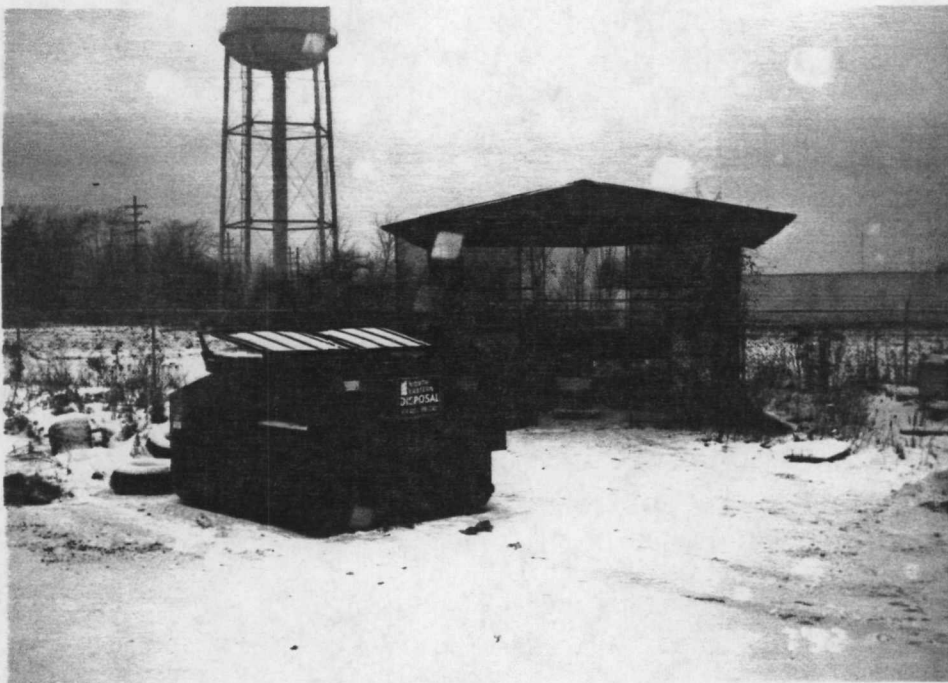
Photograph No. 7

During the VSI, the unit contained about 2 cubic yards of general refuse, including waste paint filters. PRC noted no evidence of release (see Photograph No. 7).

Recommendations: PRC recommends that the waste paint filters currently managed in the Refuse Dumpster be characterized to determine if they contain hazardous constituents. Analytical results should be submitted to OEPA and the waste paint filters should be managed accordingly and properly disposed of.

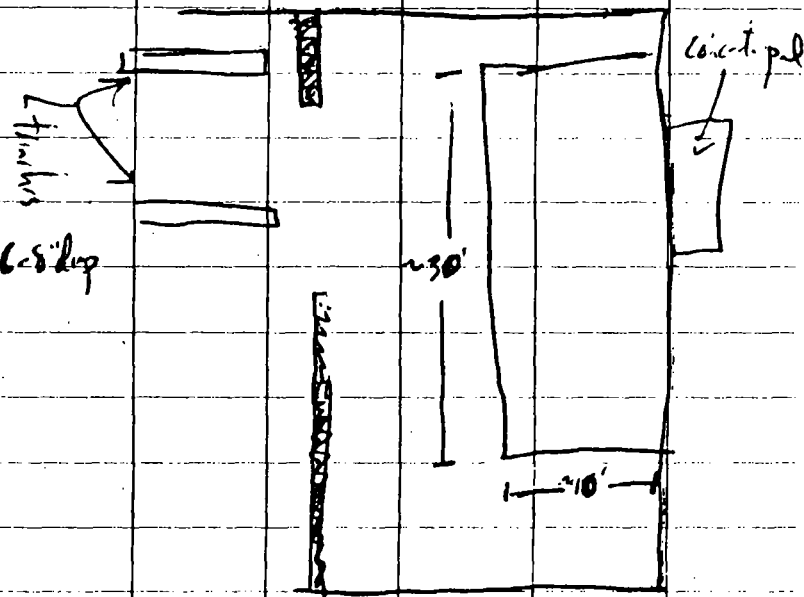
Plat #7 NW - shows former pit location (white area on floor)

Plat #8 N - Trench in floor filled w/ concrete (white area on floor)  
5/22/12
